Intel[®] Pentium[®] III Xeon[™] Processor Specification Update

Release Date: November 2000

Order Number: 244460-022

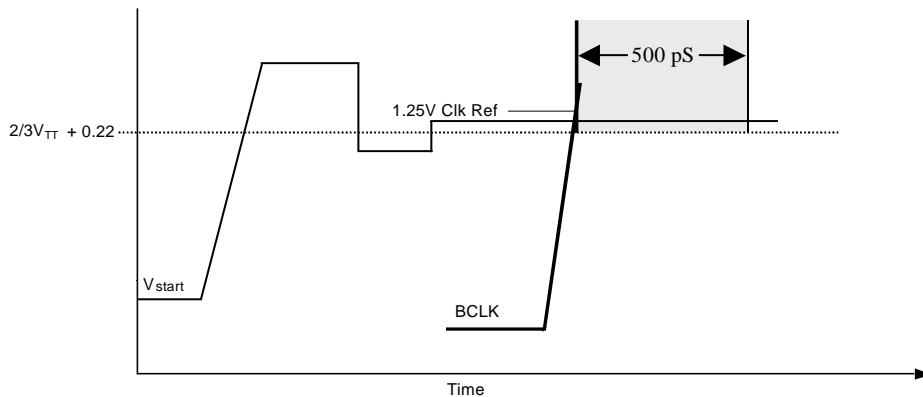
The published AGTL+ AC specification for $V_{IH(MIN)}$ is $(2/3 \cdot V_{TT}) + 0.1$ Volts.

Intel has characterized the new AGTL+ AC specification for $V_{IH(MIN)}$ on the processor's RS0# signal to be: $(2/3 \cdot V_{TT}) + 0.22$ Volts within 500 picoseconds following the rising edge of BCLK crossing the 1.25-Volt threshold. See below.

Implication: The deviation from the published specification results in decreased noise margin on the RS0# processor input. This decreased noise margin has been observed to be particularly detrimental in system environments where the RS0# processor input is being driven by an I/O buffer with a pull-up device (such as a p-channel transistor) that is switched off mid-cycle. Systems that employ I/O buffers that keep the pull-up device on for the entire cycle are significantly less affected by this erratum. The reduction in noise margin may lead to the generation of BINIT# (when enabled) resulting in a system reset, otherwise this condition may lead to a system "hang" condition.

Workaround: If a system design cannot meet the specification deviation, the following areas should be carefully examined to assure that additional margin exists in order to compensate for any deficit observed with respect to the newly characterized $V_{IH(MIN)}$ specification:

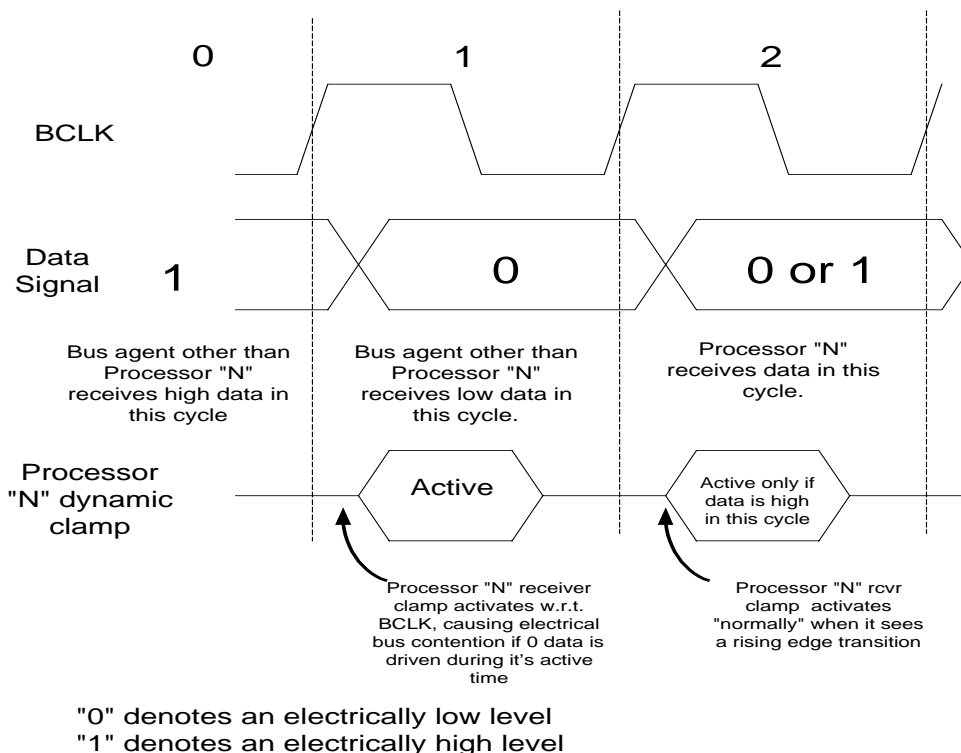
Problem: Falling edge ledge push-out and undershoot may be seen on AGTL+ data and data bus ECC signals. The AGTL+ receiver's dynamic clamp circuit activates (i.e. clamps the signal to an electrically high level) in certain cycles when data is driven to an electrically low level by another agent.

Implication: This erratum only occurs on a processor that does not receive data in that particular cycle. More specifically, this erratum only occurs when a specific processor does not receive data in the current BCLK period, but receives data in the very next period. Therefore, the processor inducing this falling edge noise (on data and data bus ECC signals) will not actually read the data in that cycle. See below for an illustration of this erratum affecting a processor denoted Processor "N". The falling edge ledges and undershoots may affect the signal quality and/or timing at agents that receive data in that cycle. Therefore, the impact of this erratum is highly dependent on system bus design.

Workaround: Evaluate system bus signal quality and timing margin at the valid receiving agent as a result of this falling edge noise. Due to dependence upon system bus design, bus layout may be evaluated to determine the need for improvements in signal quality and timing margin at the valid receiving agent as a result of this receiver-induced falling edge noise.
